***Final***  
***Phase I Environmental Site Assessment***  
***Theodore Roosevelt National Park***  
***Tract 03-108***  
***Billings County, North Dakota***

**July 2003**

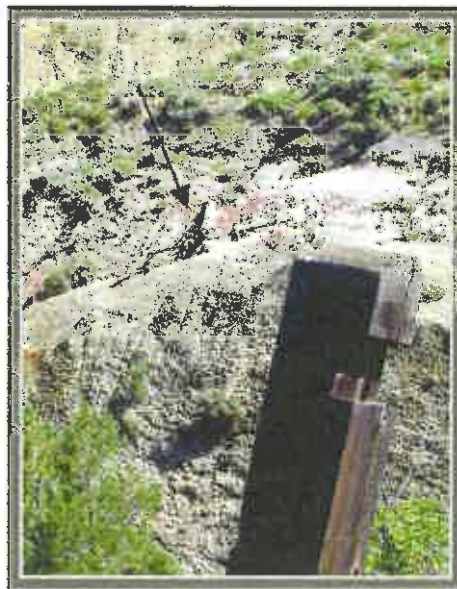
5. Telephone pole on adjacent property to the north

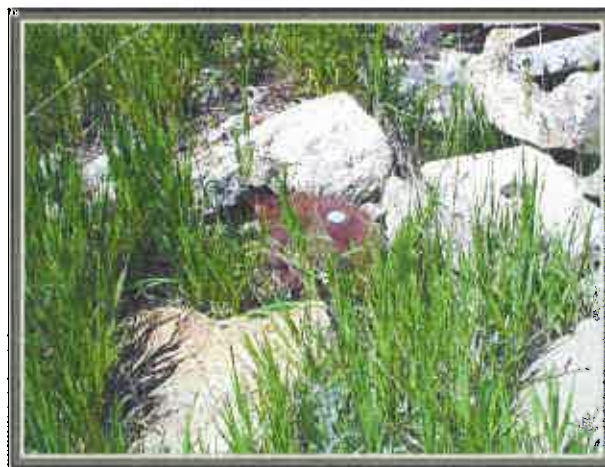
- Recognized environmental conditions were not observed during the visual site inspection.
- According to Mr. Bruce Kaye, the North Dakota Department of Transportation (DOT) has periodically disposed of construction debris (concrete and metal scraps – including a drum top) on the southeast corner of the property in a gully near a culvert approximately 100-feet from Interstate 94. Mr. Kaye said that the south property boundary was recently changed to abut the interstate. It is unclear when the materials were disposed, so the DOT crews could have dumped the debris when the property next to the interstate was the highway right-of-way. According to Mr. Norbert Sickler, the debris has been on the property since he purchased it approximately 20 years ago. It is possible the debris is being used as riprap, since it stems from a culvert. In addition, small pieces of wood and asphalt debris were scattered around the location of old Highway 10. It is assumed that this debris is from the deconstruction of the road.

10. Debris on southwest corner of property in gully  
(metal and concrete)

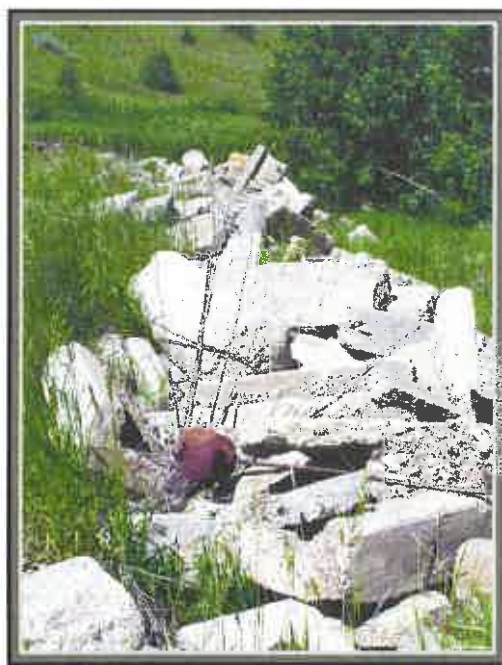
12. Debris on southwest corner of property in gully (metal and concrete)
